Practical Structural Design Guide for the Preservation and Renovation of Historical Stone Buildings

Bachelor's thesis
Degree Programme in Construction Engineering
Spring 2025
Mārtiņš Vīksna

Subject Practical Structural Design Guide for the Preservation and Renovation of Historical Stone Building

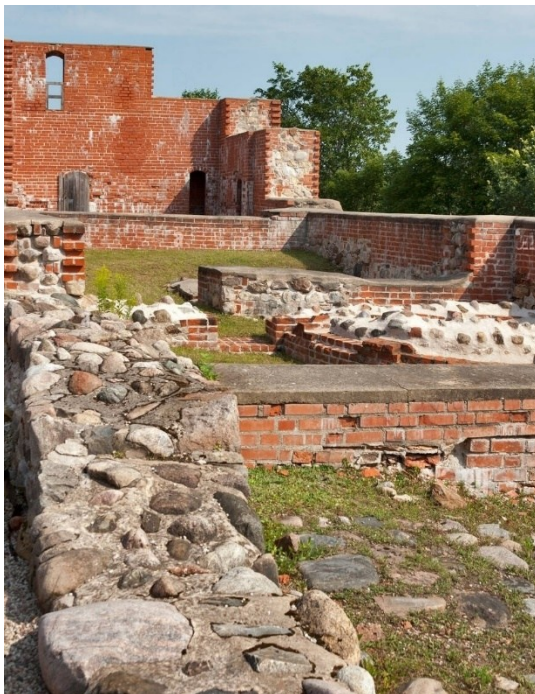
Figure 1. Turaida castle brick masonry walls with rubble stone core (Latvia) (*Alamy*, n.d.)

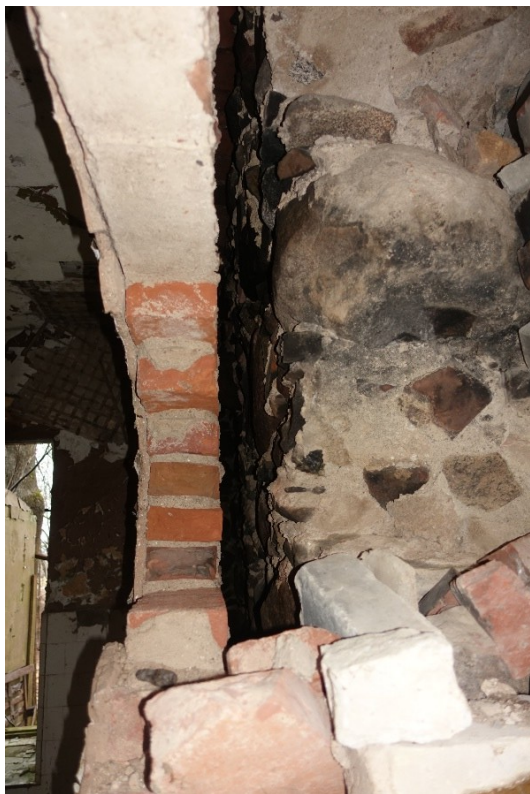
Figure 2. In the 20th century, a newly introduced insulation layer (Latvia). (February 24, 2025)

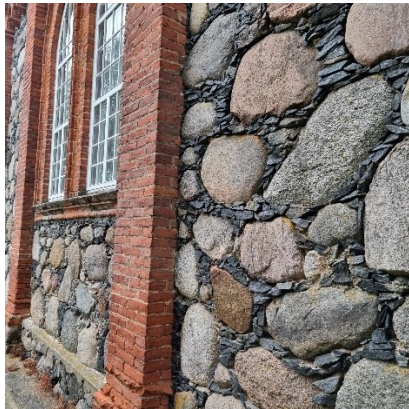
Figure 7. Salnava Catholic Church. (August 23, 2024)

Mortar, as a binding material for the joints, has lost its visual significance in some structures, as the boulders and rubble are so densely packed that the mortar is barely visible. While such examples are relatively rare, they can be found throughout Latvia in rural and sacral architecture. An imposing example is the Salnava Catholic church (Figure 7.), built in the second half of the 19th century. In some of the cases, a rare combination of brick and rubble was also used for construction. (Zilgalvis, n.d.)

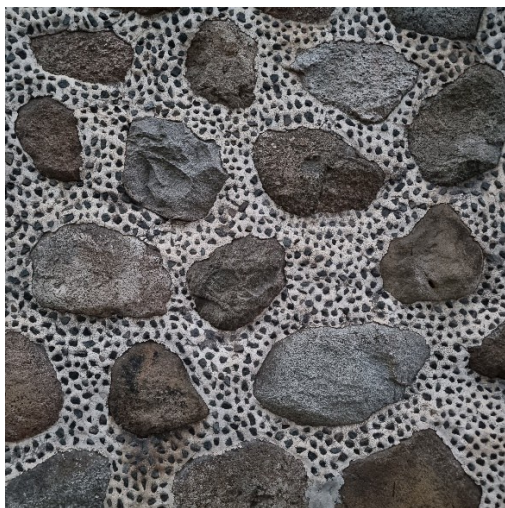
Figure 8. Varakļāni (Warkland) Lutheran Church. (August 23, 2024)

In the rubble style, there is a secondary type of structure where both the boulders and the mortar are equally essential and visually significant on the façade. Red brick is used in openings, cornices, and many other structurally necessary areas. This style is widespread across all regions of Latvia and can be seen in many buildings, including sacral structures, manor buildings, and other types of structures. A notable example in this category is the Varakļāni (Warkland) Lutheran Church, built in 1878 (Figure 8.).

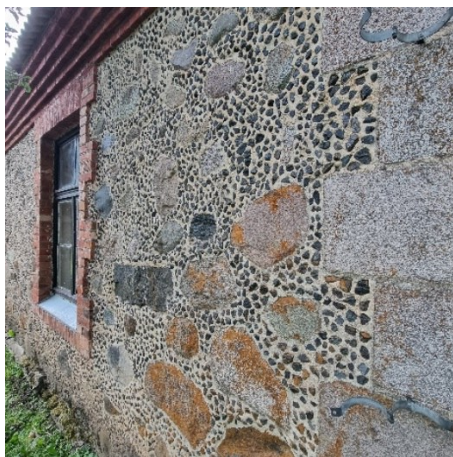
Figure 10. Variation of the rubble style in the city of Rujiena. (Latvia) (August 23, 2024)

Another variation of the rubble style involves a façade where rubble imprints play the leading role. In this approach, the boulders appear to float in the sea of rubble, but unlike in other styles where the mortar is barely visible, here, the mortar-based surface has its own meaning and significance. Some of the facades were usually handmade, showcasing the stonemason's skill and attention to detail.

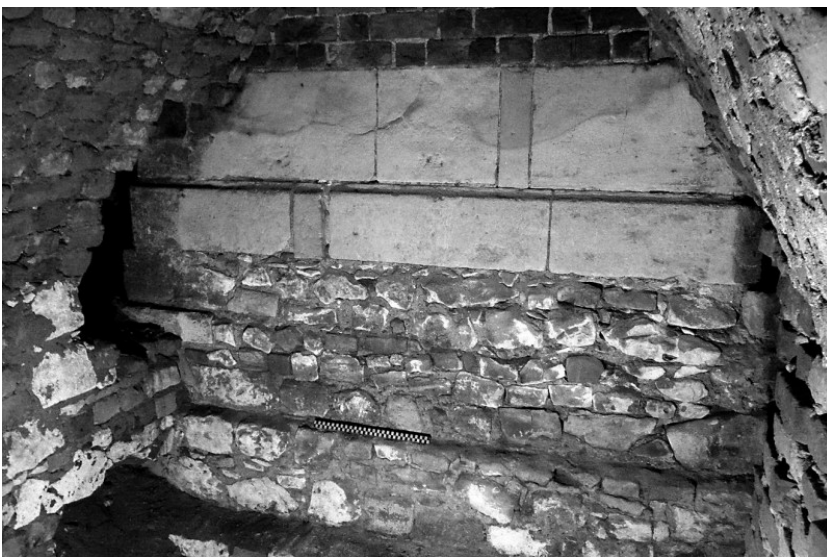
Figure 13. An example of a Gothic foundation in Poland (Saint Mary's Basilica). (Firlet, Kadłuczka, & Pianowski, 2011)

In the example above, it is possible to see the widening type of the stone foundation; moreover, soil conditions and the overall structure of the foundation show that the interactions between a structure and soil are considered. Many historical buildings had no foundation in the modern sense because the foundation often is the extension of basement walls, without any or with little widening. Foundations without widening in the weak soils may cause the possible over-loadings of the soil, so cracks or defects can appear.

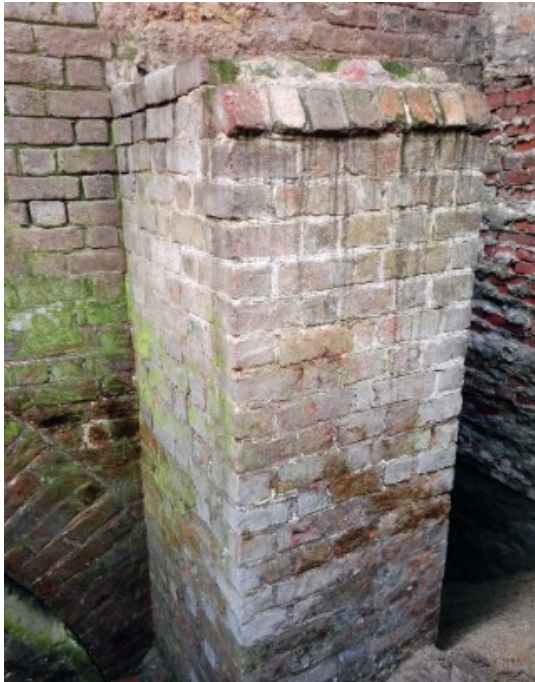
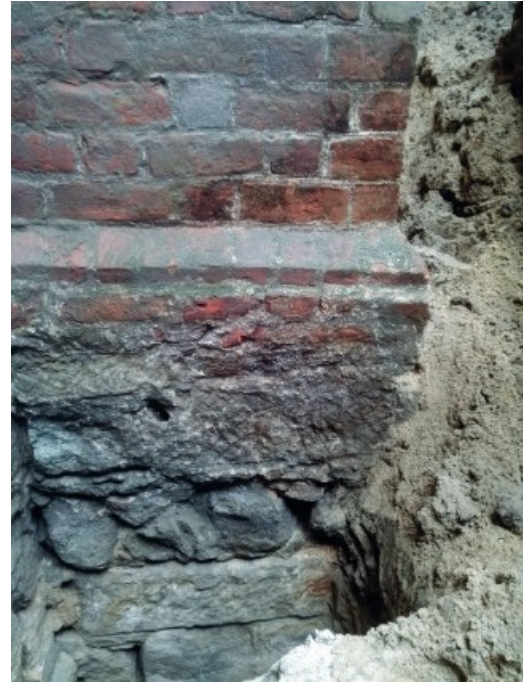
Figure 15. Historical masonry foundation technology and connection. (a) The figure shows the buttress, upper offset and arch connection. (b) The lower part of the buttress. Visible foundation technology and profiled offset made of brick fittings. (Kmieciak & Szwed, 2022)

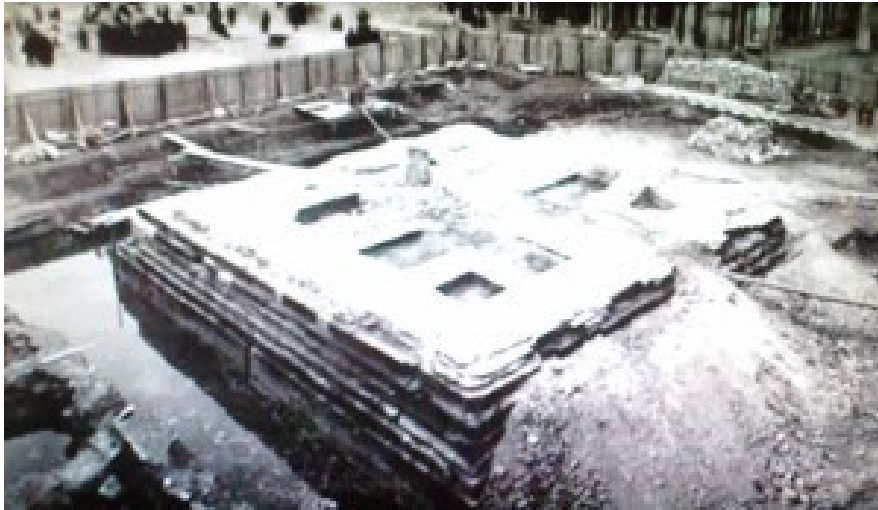
Figure 19. Foundation of the St Mark's bell tower after the collapse. (Umberto Sartori, 2012)

The bell tower of St Mark’s in Venice is a spectacular example of foundation reconstruction. (Colombo & Colleselli, 1997, pp. 435-445)(Figure 19.). The original tower collapsed in 1902 due to poor load-bearing

characteristics and various mistakes during the renovation. The tower was rebuilt in the same place as the foundation, which was found to be in good condition. It was retained and enlarged by a greater outer wall, which increased the load-bearing capacity of the foundation, which mainly consisted of over 3000 larch piles.

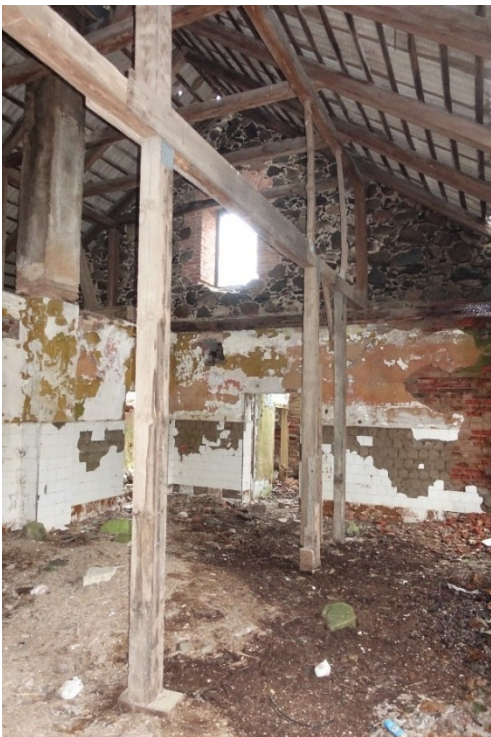
Figure 35. The existing timber Roof structure. (February 24, 2025)

The building's roof structure is composed of simple timber truss systems at both ends, while the central section is supported by timber columns connected to load-transfer elements (Figure 35). The roof covering is composed of asbestos, a material commonly used during the Soviet era in Latvia. Since the roof covering is intended for complete replacement, it is crucial to carefully remove the asbestos panels to prevent any environmental contamination. (personal project, n.d.)

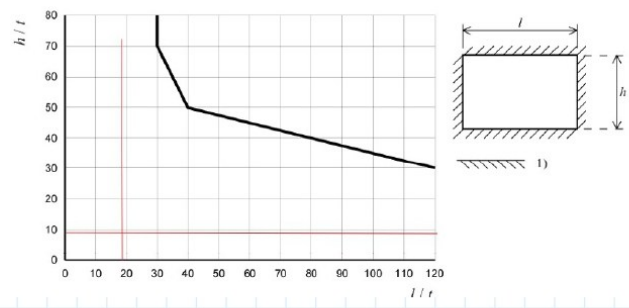
- (1) Notwithstanding the ability of a wall to satisfy the ultimate limit state, which must be verified, its size should be limited to that which results from use of figures F.1, F.2 or F.3, depending on the restraint conditions as shown on the figures, where h is the clear height of the wall, l is the length of the wall and t is the thickness of the wall; for cavity walls use t_{ef} in place of t .
- (2) Where walls are restrained at the top but not at the ends, h should be limited to $30 t$.
- (3) This annex is valid when the thickness of the wall, or one leaf of a cavity wall, is not less than 100 mm.
